Salmon Recovery Funding Board Effectiveness Monitoring Program 2017 Annual Report

REACH-SCALE PROJECT EFFECTIVENESS MONITORING PROGRAM

2017 ANNUAL REPORT

February 2018

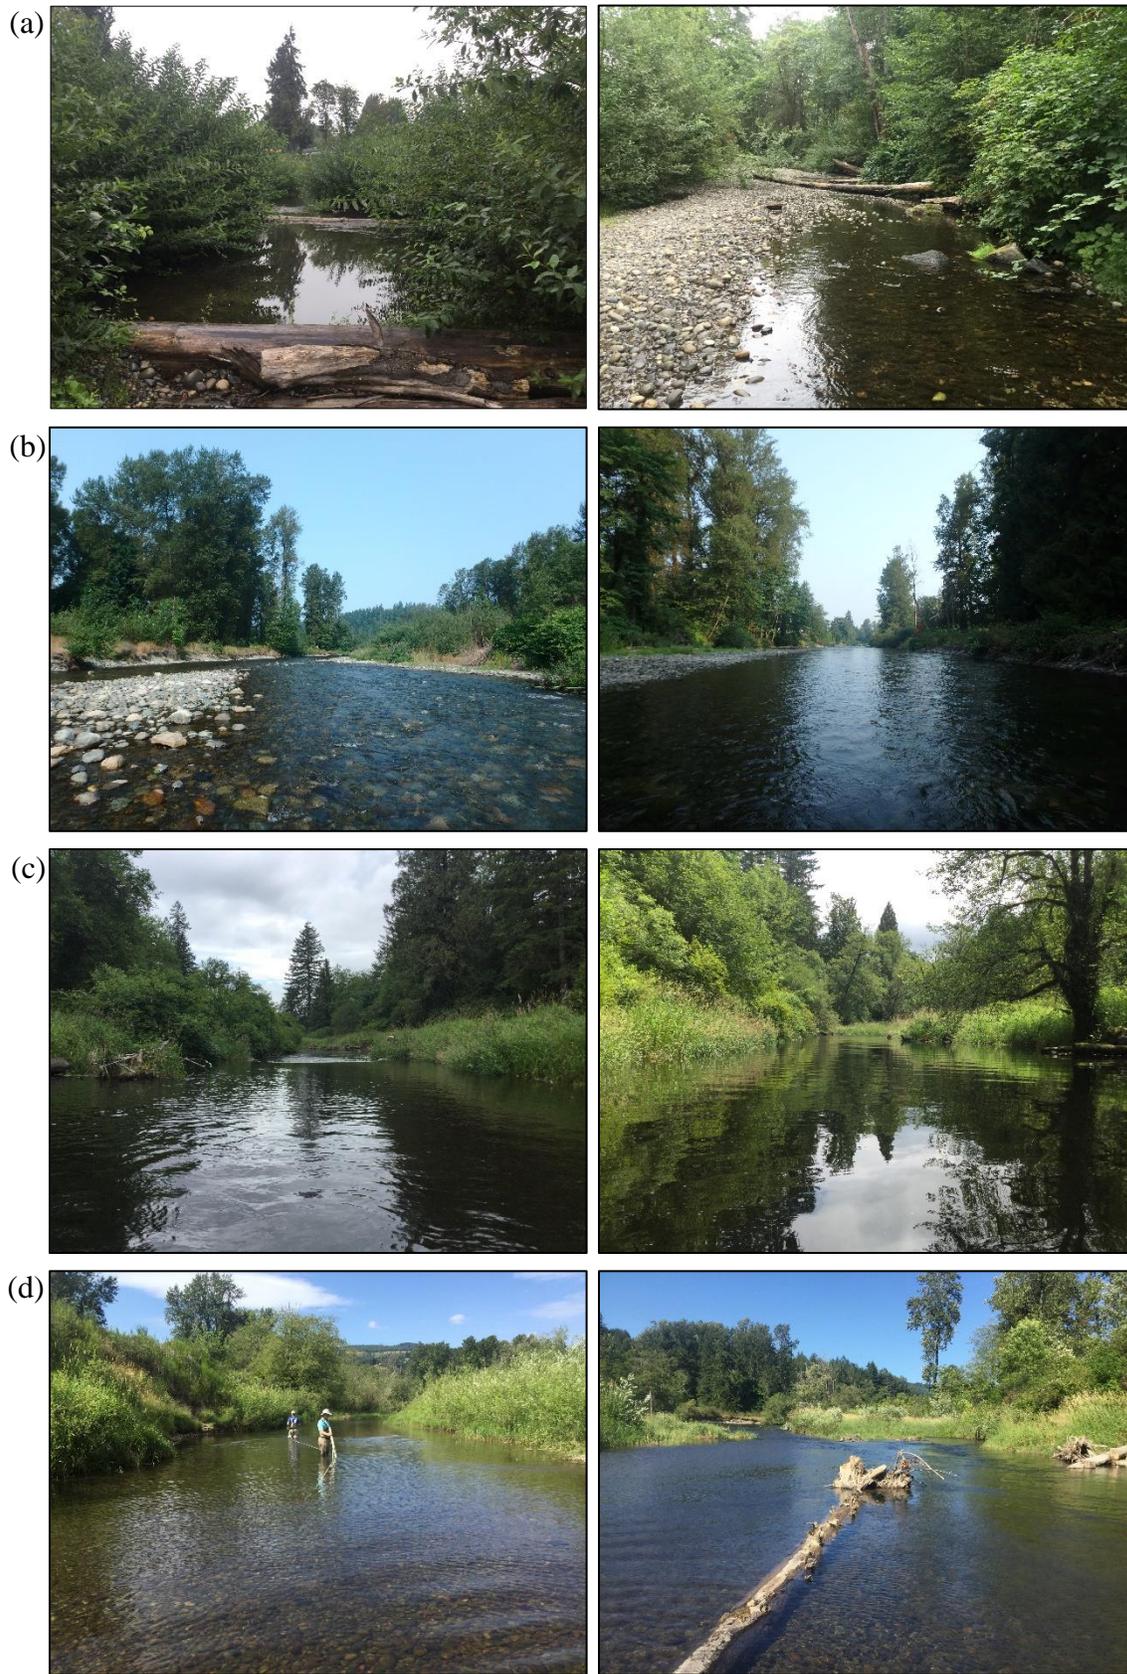
Figure 2. Impact (left) and control (right) reaches for (a) 04-1209 Chico Creek, (b) 04-1660 Cedar Rapids, (c) 05-1533 Doty Edwards, and (d) 11-1315 Eagle Island.

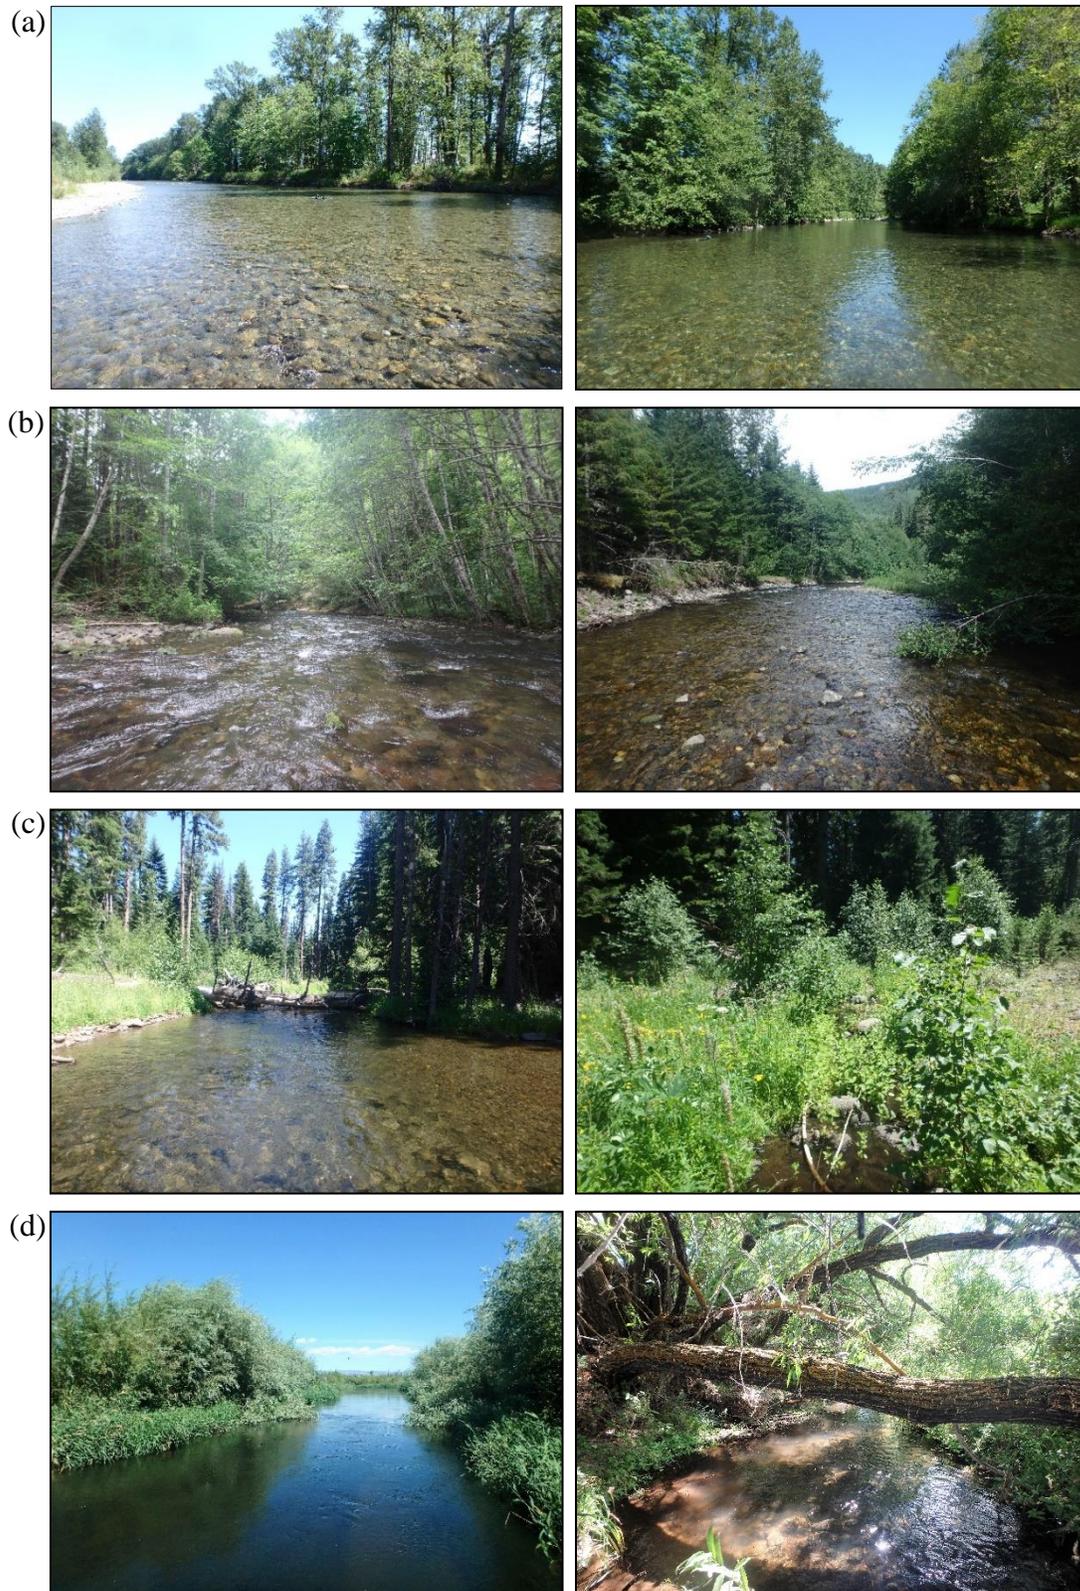
Figure 7. Impact (left) and control (right) reaches for (a) 04-1596 Lower Tolt, (b) 06-2223 Greenwater River, (c) 06-2277 Upper Klickitat, and (d) 07-1519 Reecer Creek.
