SRFB Project Effectiveness Monitoring Program Final Results and Recommendations

**Salmon Recovery Funding Board Reach-Scale
Project Effectiveness Monitoring Program
2018 Final Report**

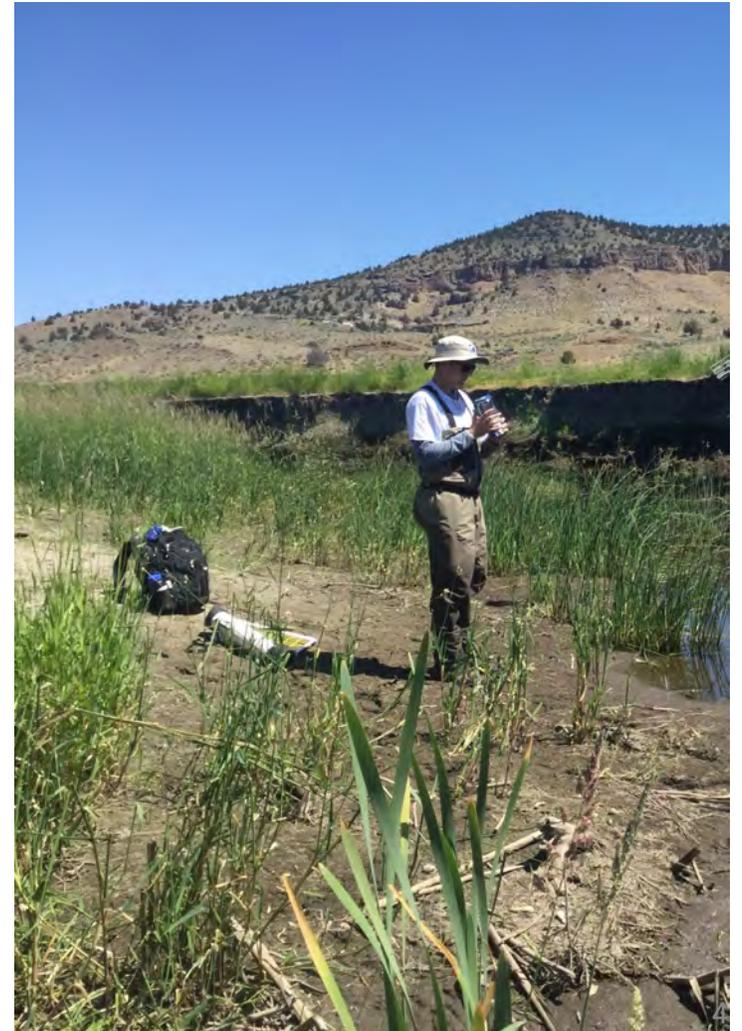
- Multiple Before-After Control-Impact Design
- 1 year before, years 1, 3, 5, and 10 after restoration (impact)
- Protocols developed by SRFB (Crawford et al. 2011), which were based on EMAP Program
- Columbia Habitat Monitoring Program (CHaMP) at some sites from 2012+

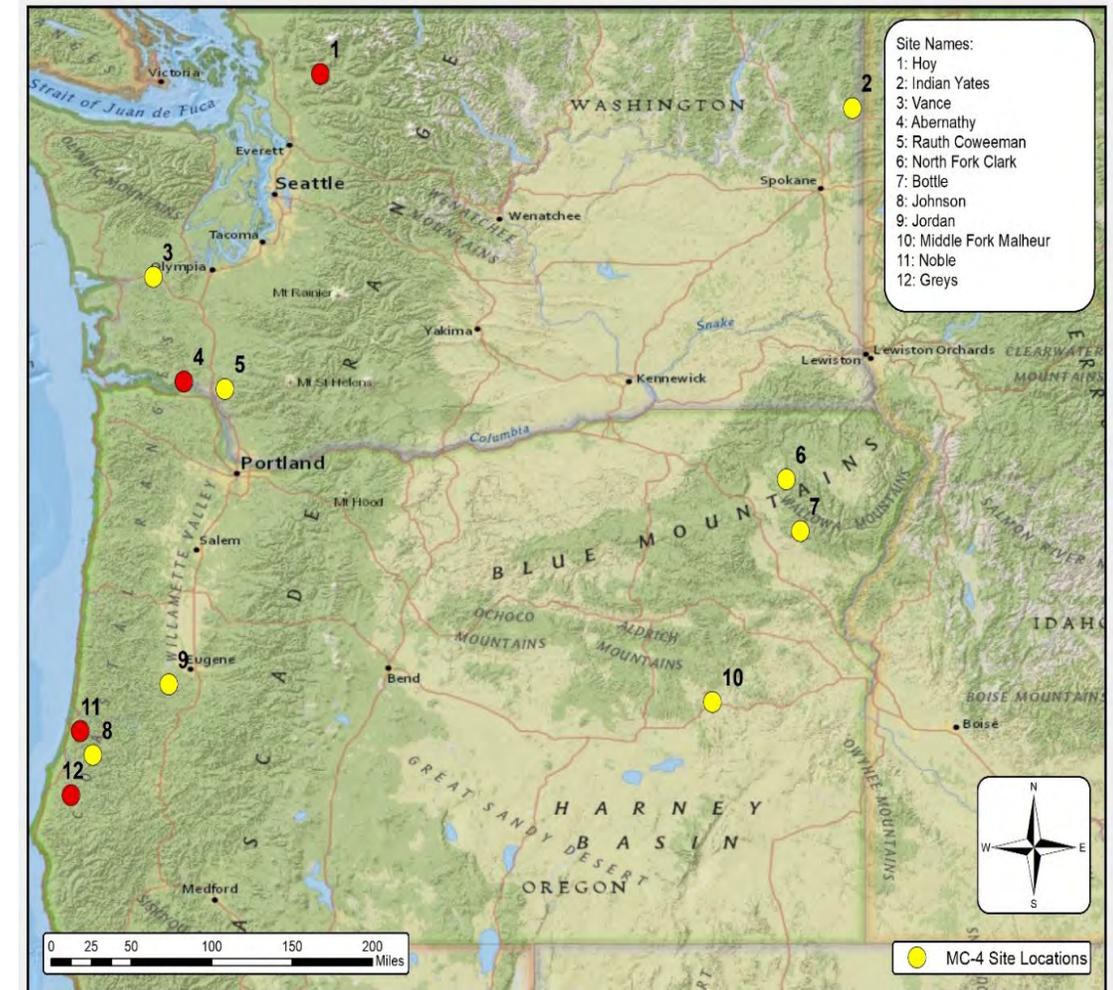
MC-4 Livestock - Results

Metric	Years Compared	P-value
Bank Erosion (%)	0↔1	0.02*
	0↔3	0.04*
	0↔5	0.03*
	0↔10	0.01*
Riparian Vegetation Structure (%)	0↔1	0.81
	0↔3	0.28
	0↔5	0.82
	0↔10	0.04*
Bank Canopy Cover	0↔1	0.81
	0↔3	0.45
	0↔5	0.03*
	0↔10	0.50

MC-4 Livestock – Interpretation of Results

- Results for riparian structure and bank erosion consistent with literature
- Future effectiveness monitoring
 - More rigorous selection of control and treatments
 - Stratify by ecoregion
 - More rigorous/quantitative monitoring protocols
 - Limited info exist on aquatic biota, however, ...
- Focus on compliance/implementation

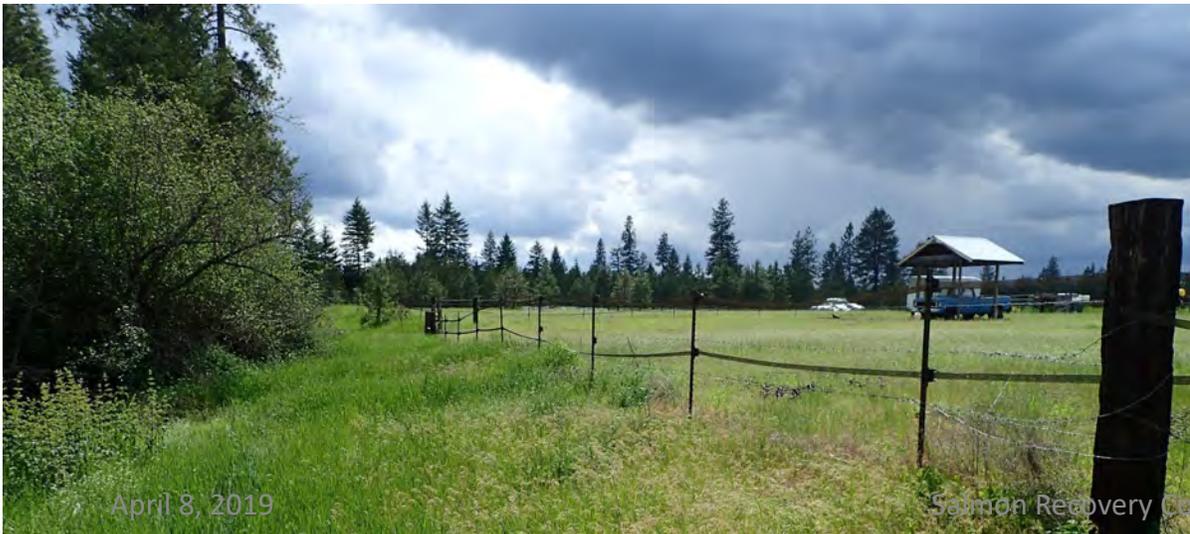
MC-4 Livestock - Results

Exclusion Assessment	Year 1	Year 3	Year 5	Year 10
# of sites with fencing not Intact and/or not functioning as intended	0	1	4	4
# of sites with signs of Livestock in impact	1	3	4	4

- Many impact reaches (livestock exclusion) had evidence of livestock
- In year 10, 5 control (livestock not excluded) reaches had no evidence of livestock

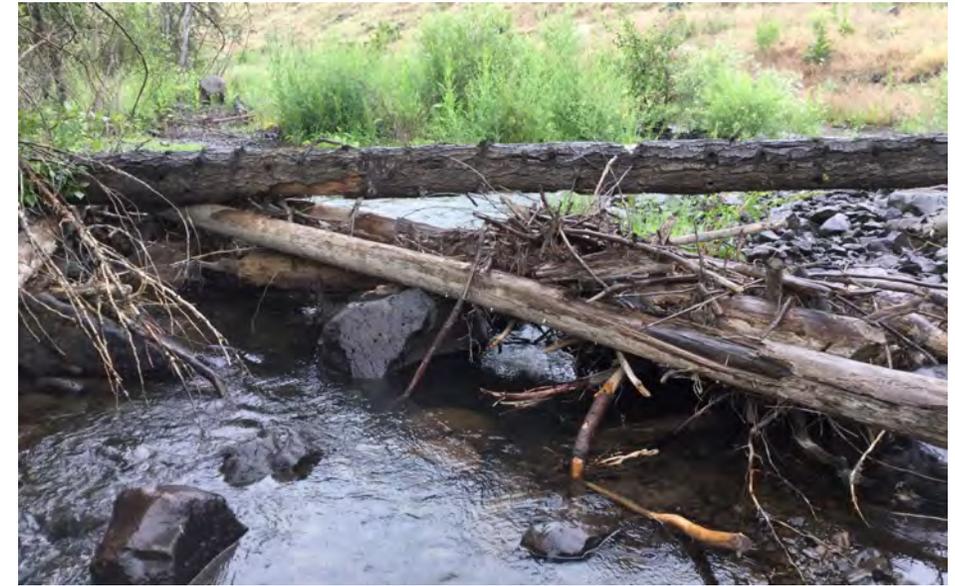
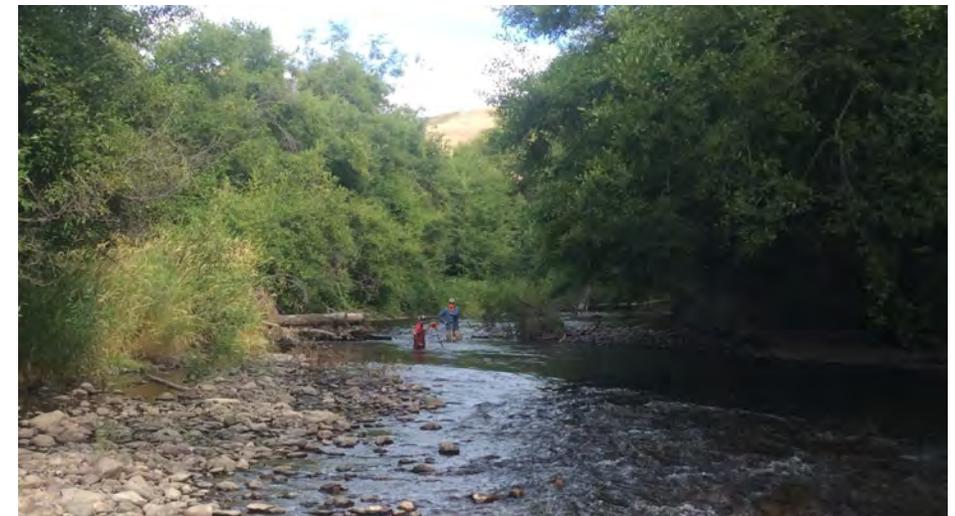
MC-2 Instream - Results

Metric	P –Value from T-test	
	Year 10 (n)	Last year sampled (n)
Vertical pool profile area (m ²)	0.28 (6)	0.13 (17)
Mean residual profile depth (cm)	0.28 (6)	0.10 (17)
Log ₁₀ LWD volume (m ³)	0.003 (6)	0.002 (17)
Chinook density (fish/m ²)	0.56 (4)	0.50 (9)
Coho density (fish/m ²)	0.41 (5)	0.50 (8)
Steelhead density (fish/m ²)	0.16 (6)	0.08 (17)

- Most studies have found positive increase in pool area, complexity, and salmonid abundance.
- Lack of results likely for a number of reasons
 - Low number of sites monitoring for 10 years
 - Poorly matched treatments and controls
 - EMAP metrics that don't directly measure pool metrics
 - Lack of geographic stratification
- Future monitoring of instream projects requires
 - stratifying by ecoregions
 - seasonal fish sampling (summer and winter),
 - more rigorous selection of controls,
 - improved habitat survey methods
